HOSPITAL PATIENT ROOM photo courtesy Perkins+Will; may not be used without permission 15 AD1 3

HOSPITAL PATIENT ROOM: TYPICAL HAZARDS FOUND photo courtesy Perkins+Will; may not be used without permission PVC with phthalates, VOCs (adhesives, flooring) perfluorinated compounds (PVDF coating)

HOSPITAL PATIENT ROOM: ALTERNATES photo courtesy Perkins+Will; may not be used without permission

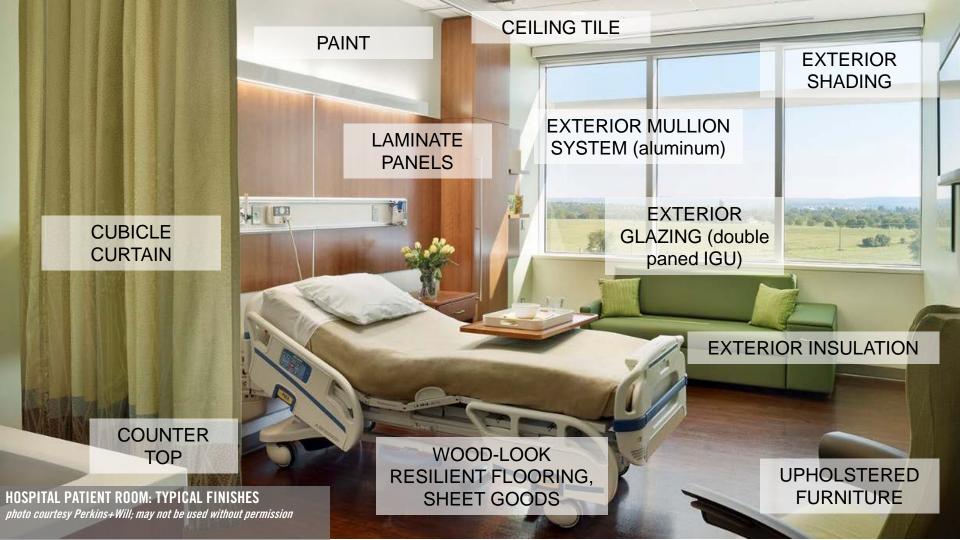
VOCs, antimicrobials (preservative or added)

VOCs (adhesives), formaldehyde (composite wood binder)

Added flame retardant, perfluorinated compounds (stain resistant treatments)

> antimicrobials (added), methyl methacrylate

perfluorinated compounds (PVDF coating)

Formaldehyde

(binder)

PVC with phthalates, chloroprene (caulks and sealants)

flame retardants, polyurethane or isocyanates

VOCs, flame retardants (upholstery foam), hexavalent chromium, PVC (plastic parts), PVC with phthalates (textile) other alternatives:

- PVC without phthalates (flooring)
- other plastic flooring types
- non-wood look flooring (rubber, linoleum, etc.)
- stone, engineered stone, sintered stone (counter top)

no added flame retardant treatment; no stain resistant treatment

> no added antimicrobial, not resin based

low/no-VOCs, no added antimicrobials

low/ no VOCs (adhesives), no added urea formaldehyde (composite wood binder) plant-based binders

anodized coating

IGU with aluminum spacer, silicone and polyisobutylene sealants

mineral (rock) or natural wool insulation

ABS or other plastic types (plastic trim), certified ANSI/ BIFMA M7.1-2011 (emissions), no flame retardants added per TB-117-2013, no stain treatments, polished metal

no alternates known at this time
